CONNECTICUT RIVER BASIN
WHATELY, MASSACHUSETTS

NORTHAMPTON RESERVOIR
(LOWER DAM)
MA 00520

PHASE I INSPECTION REPORT
NATIONAL DAM INSPECTION PROGRAM

AUGUST 1978

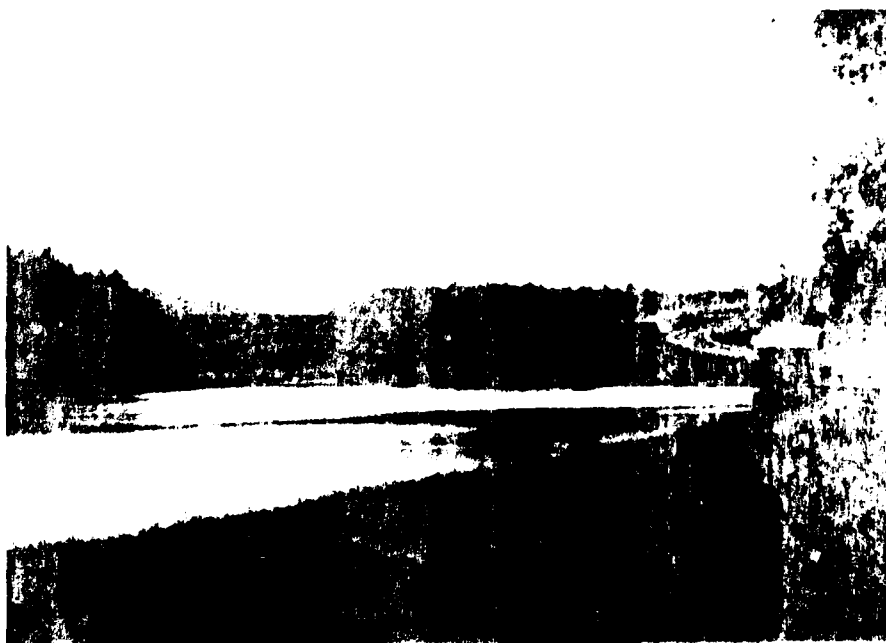
PHOTO NO. 8 - General view of reservoir from right
abutment.

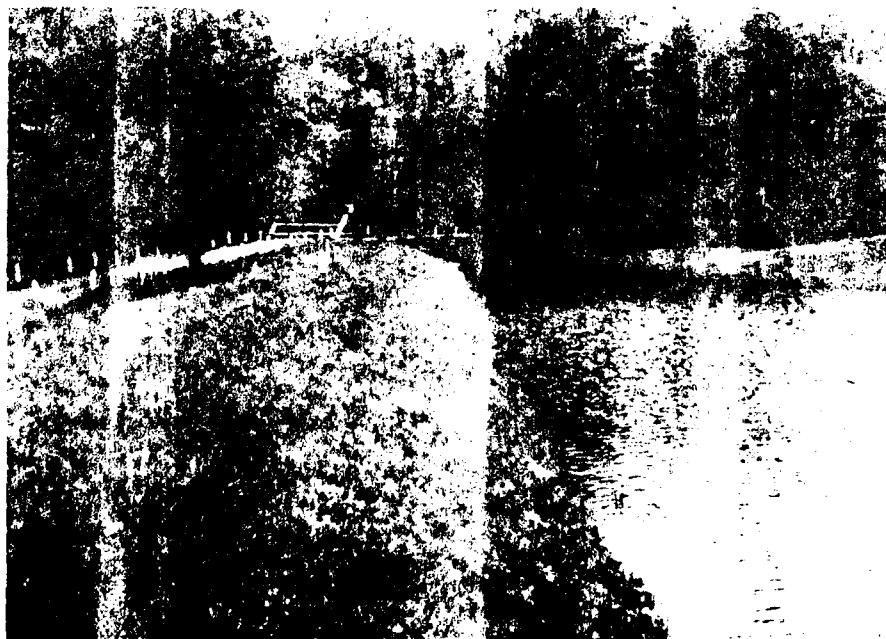
PHOTO NO. 2 - Upstream face from gate house to right abutment.
